TECOM
~~TECHNICAL REPORT~~ TR-RD-TE-95-16

TEST REPORT OF THE DIRECT STRIKE LIGHTNING TEST OF THE MCC-1
THERMAL PROTECTION SYSTEM (TPS) COATED ALUMINUM PANELS

19 May 1995

This report presents the test procedures and results of the direct strike lightning effects test on the Marshall Convergent Coating -1 (MCC-1) Thermal Protection System (TPS) coated aluminum frustum and aft skirt panels.

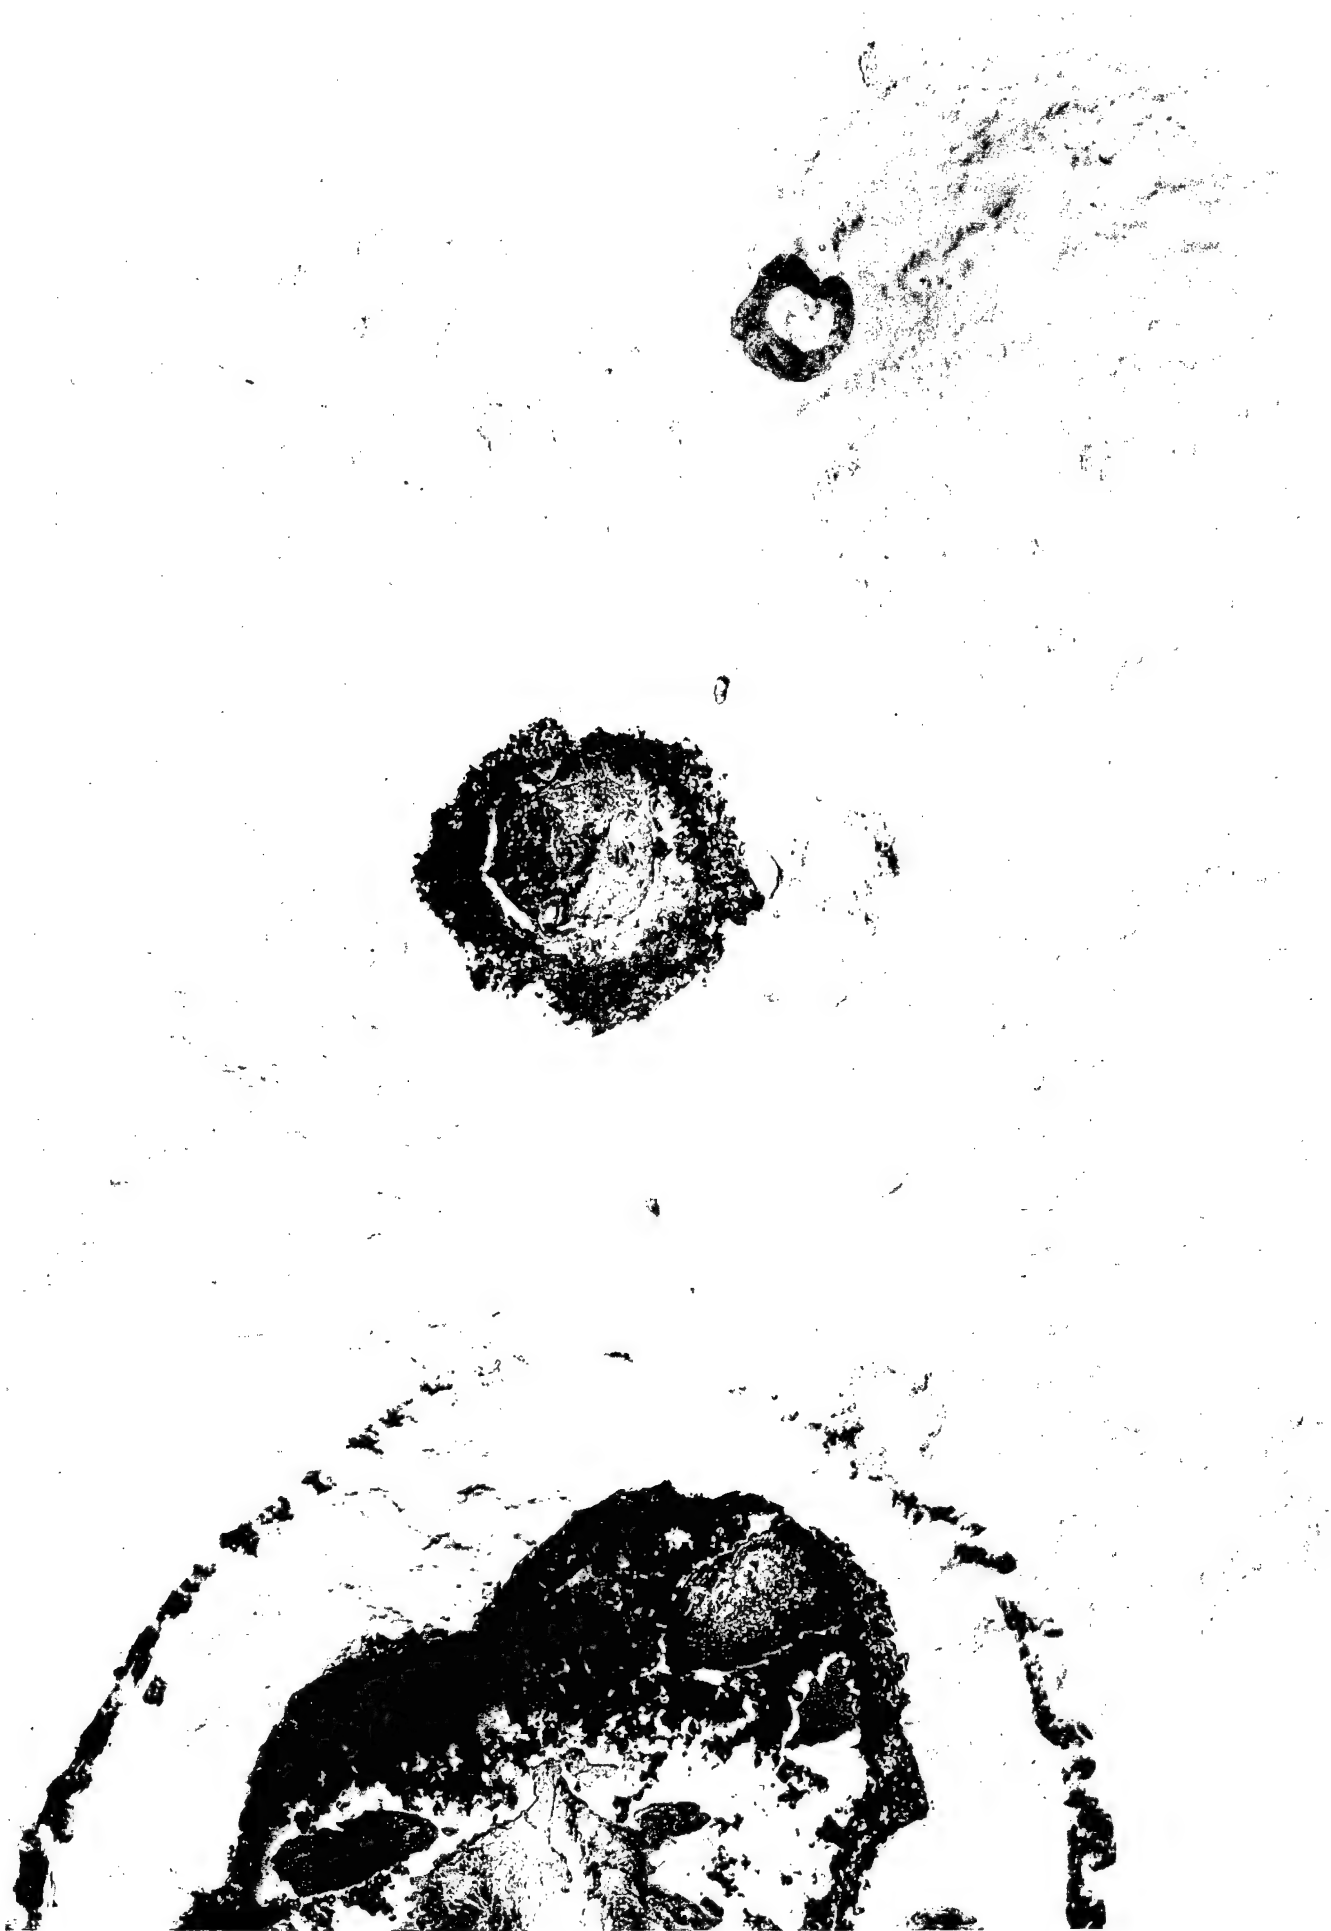
Figure B-56. Cumulative Damage Due to Components A, B, C, and D to Panel Q-6#9, Close Up View.

The application of the restrike current (Component D) direct strike lightning environment resulted in slight blackening of the MCC-1 TPS coating around the area of the discharge point. No additional loss of MCC-1 TPS coating was observed to occur due to the application of the intermediate current direct strike lightning environment. Figures B-55 through B-72 of Appendix B illustrate the cumulative damage on each panel due to the applications of the Component A, the Component B, the Component C, and the Component D direct strike lightning waveforms.

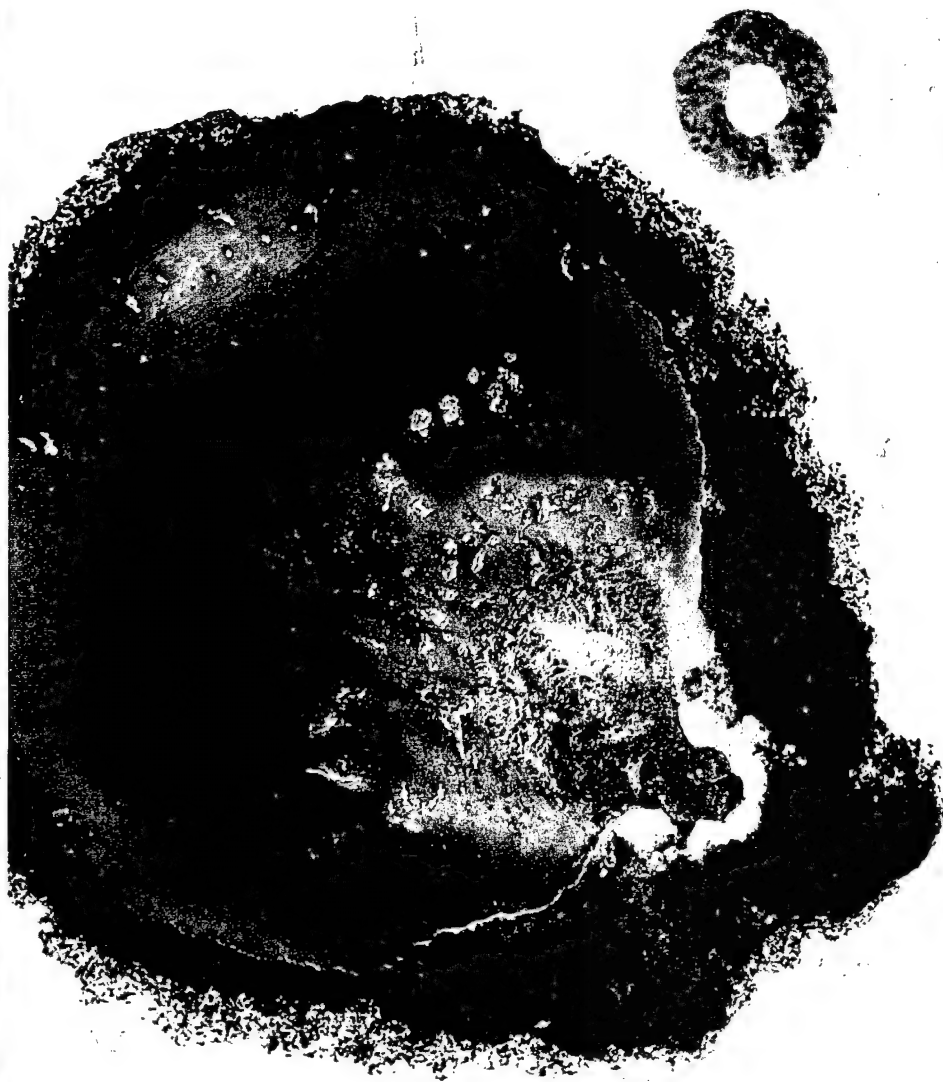
Figure B-62. Cumulative Damage Due to Components A, B, C, and D to Panel Q-13#2, Close Up View.

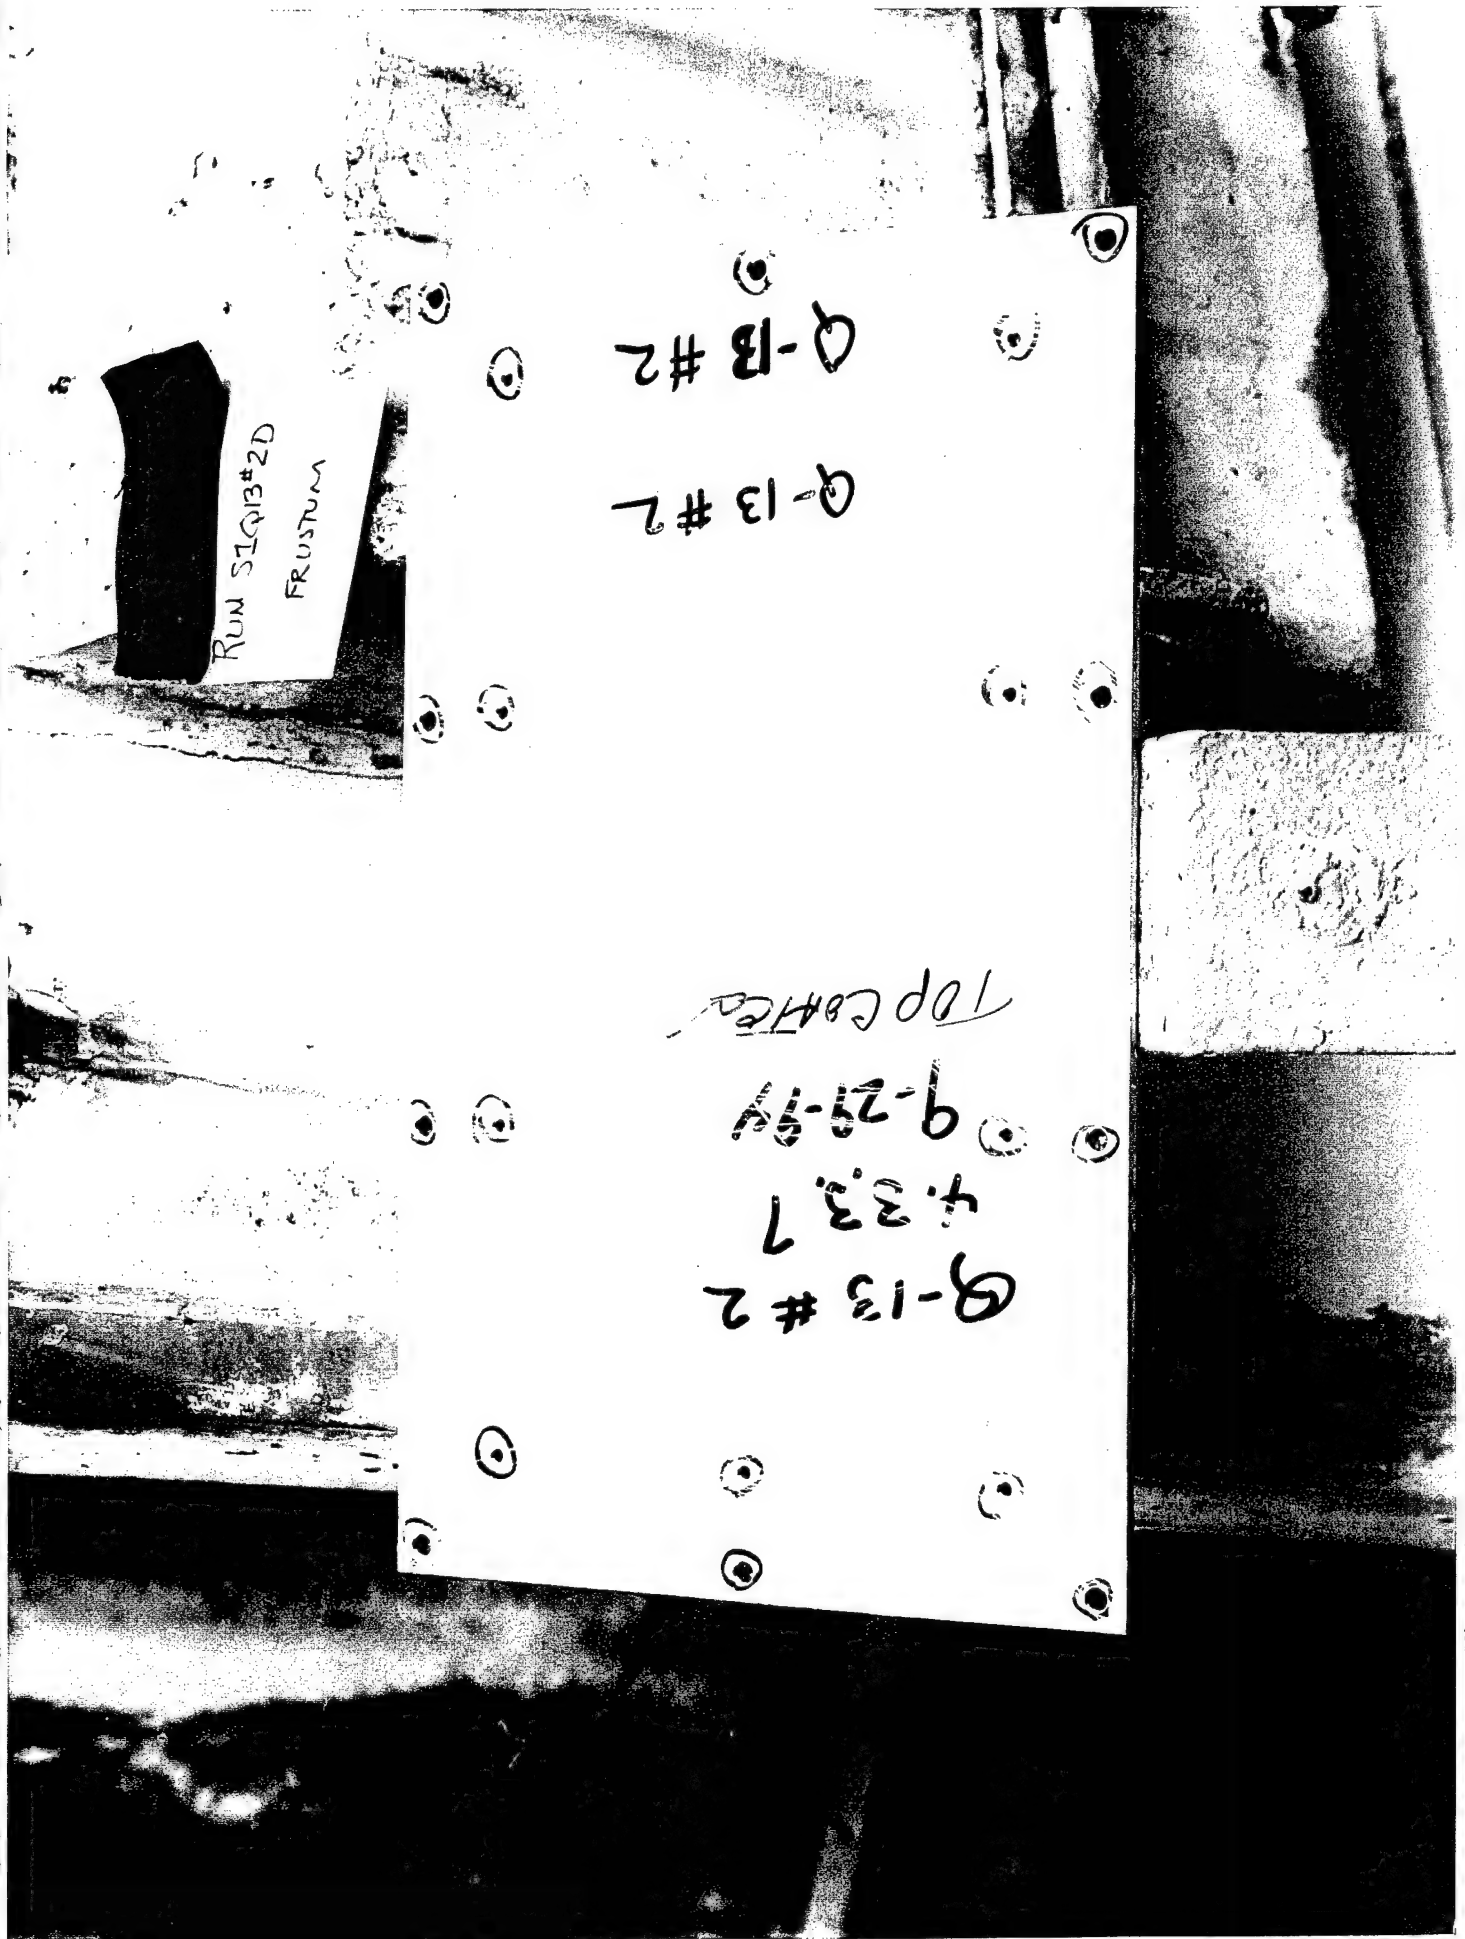
Figure B-63. Cumulative Damage Due to Components A, B, C, and D to Panel Q-13#2, Back View.

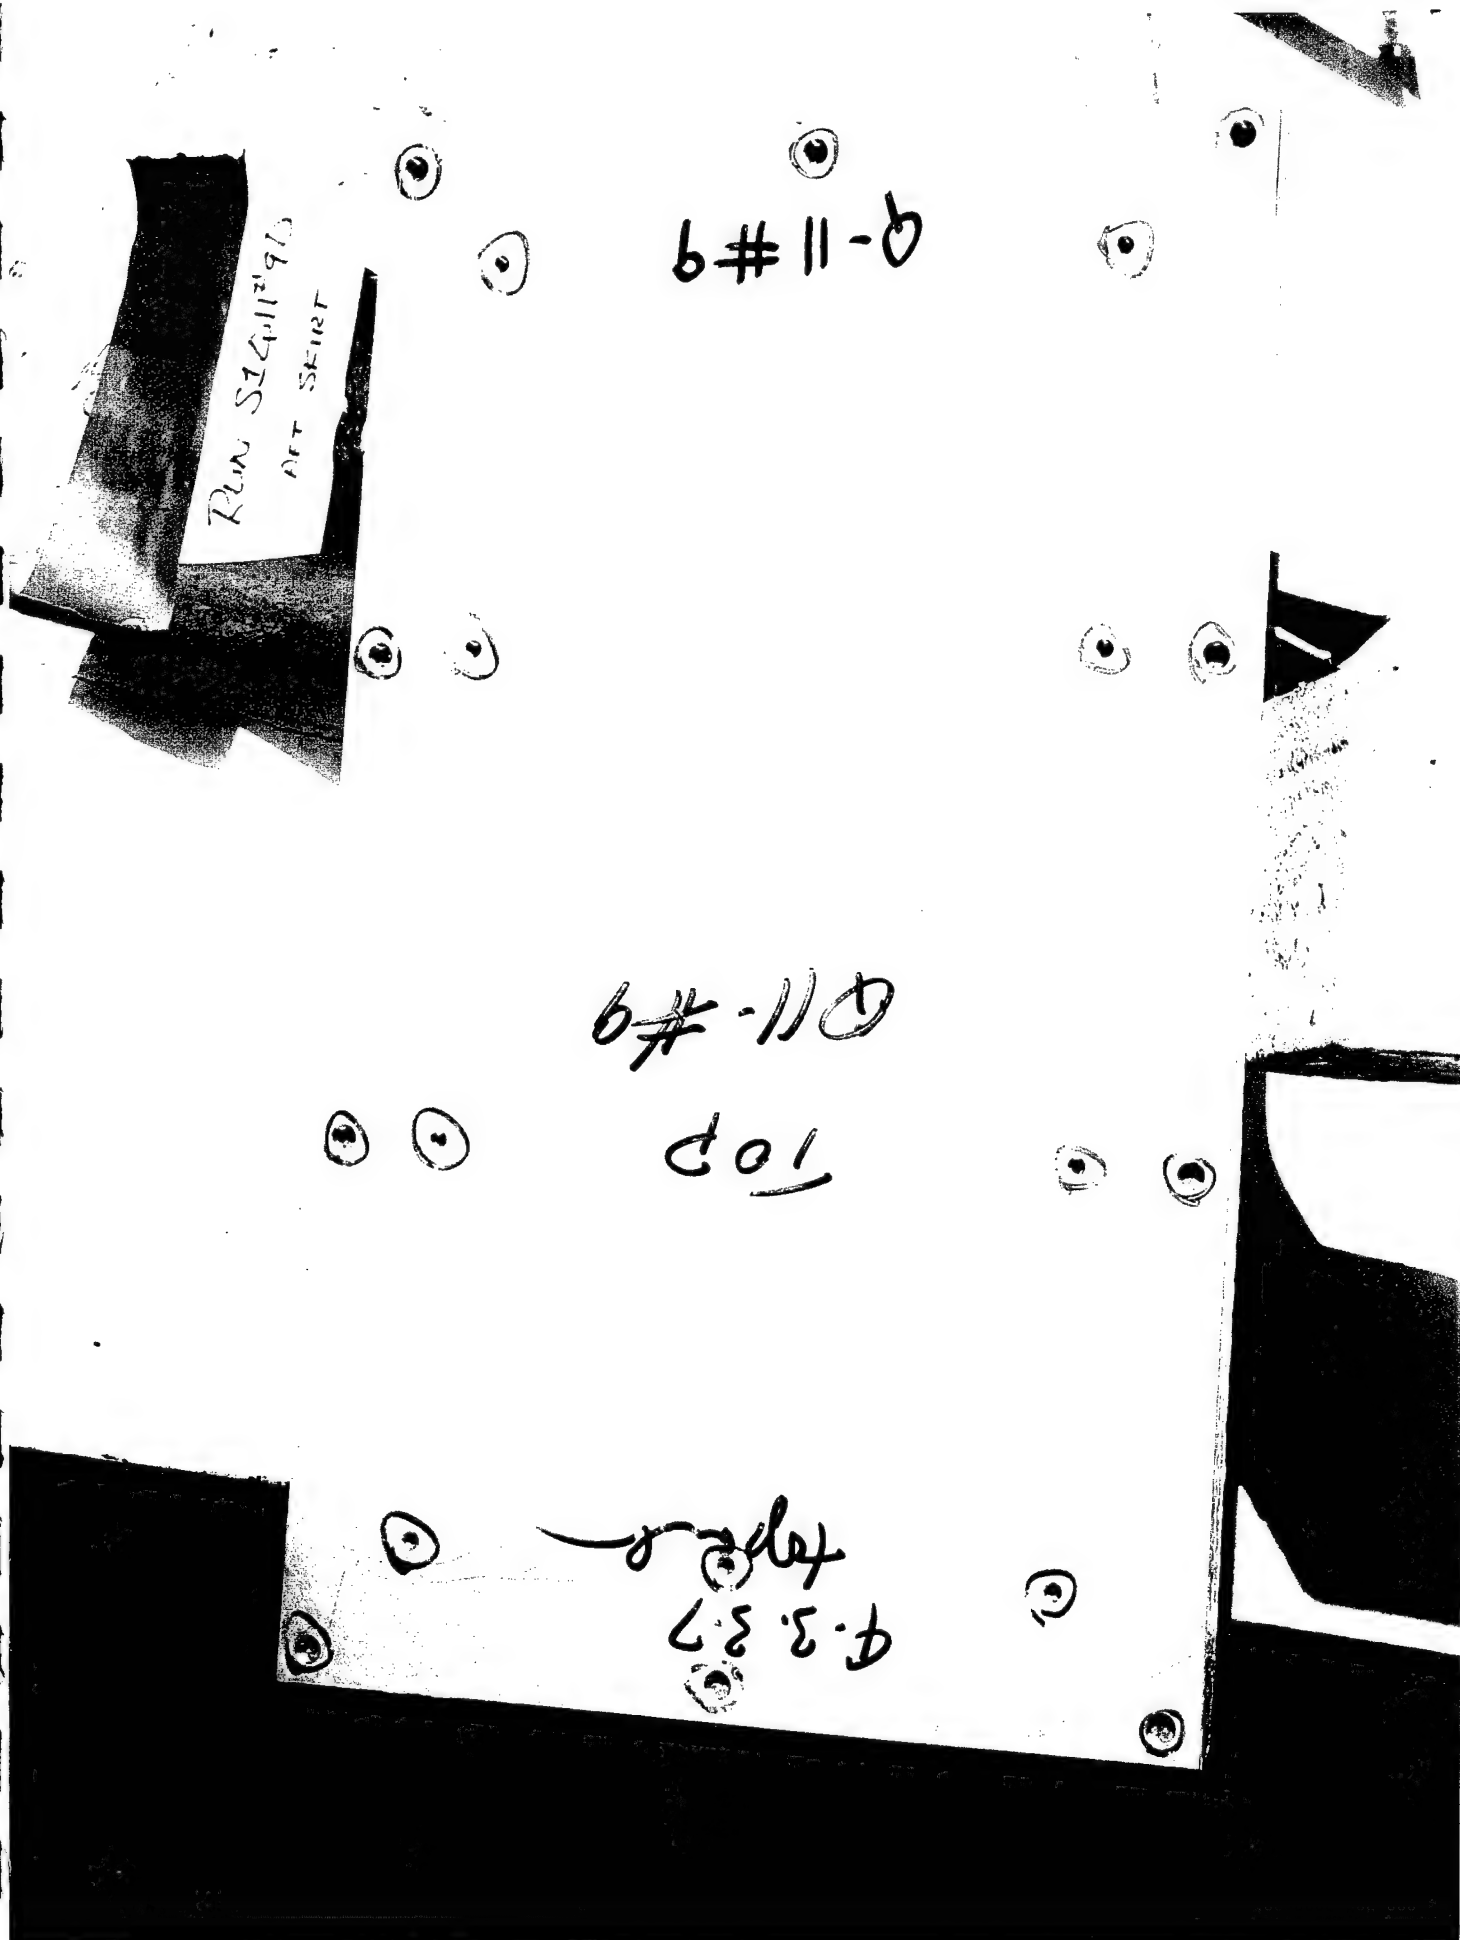
Figure B-72. Cumulative Damage Due to Components A, B, C, and D to Panel Q-11#9, Back View.

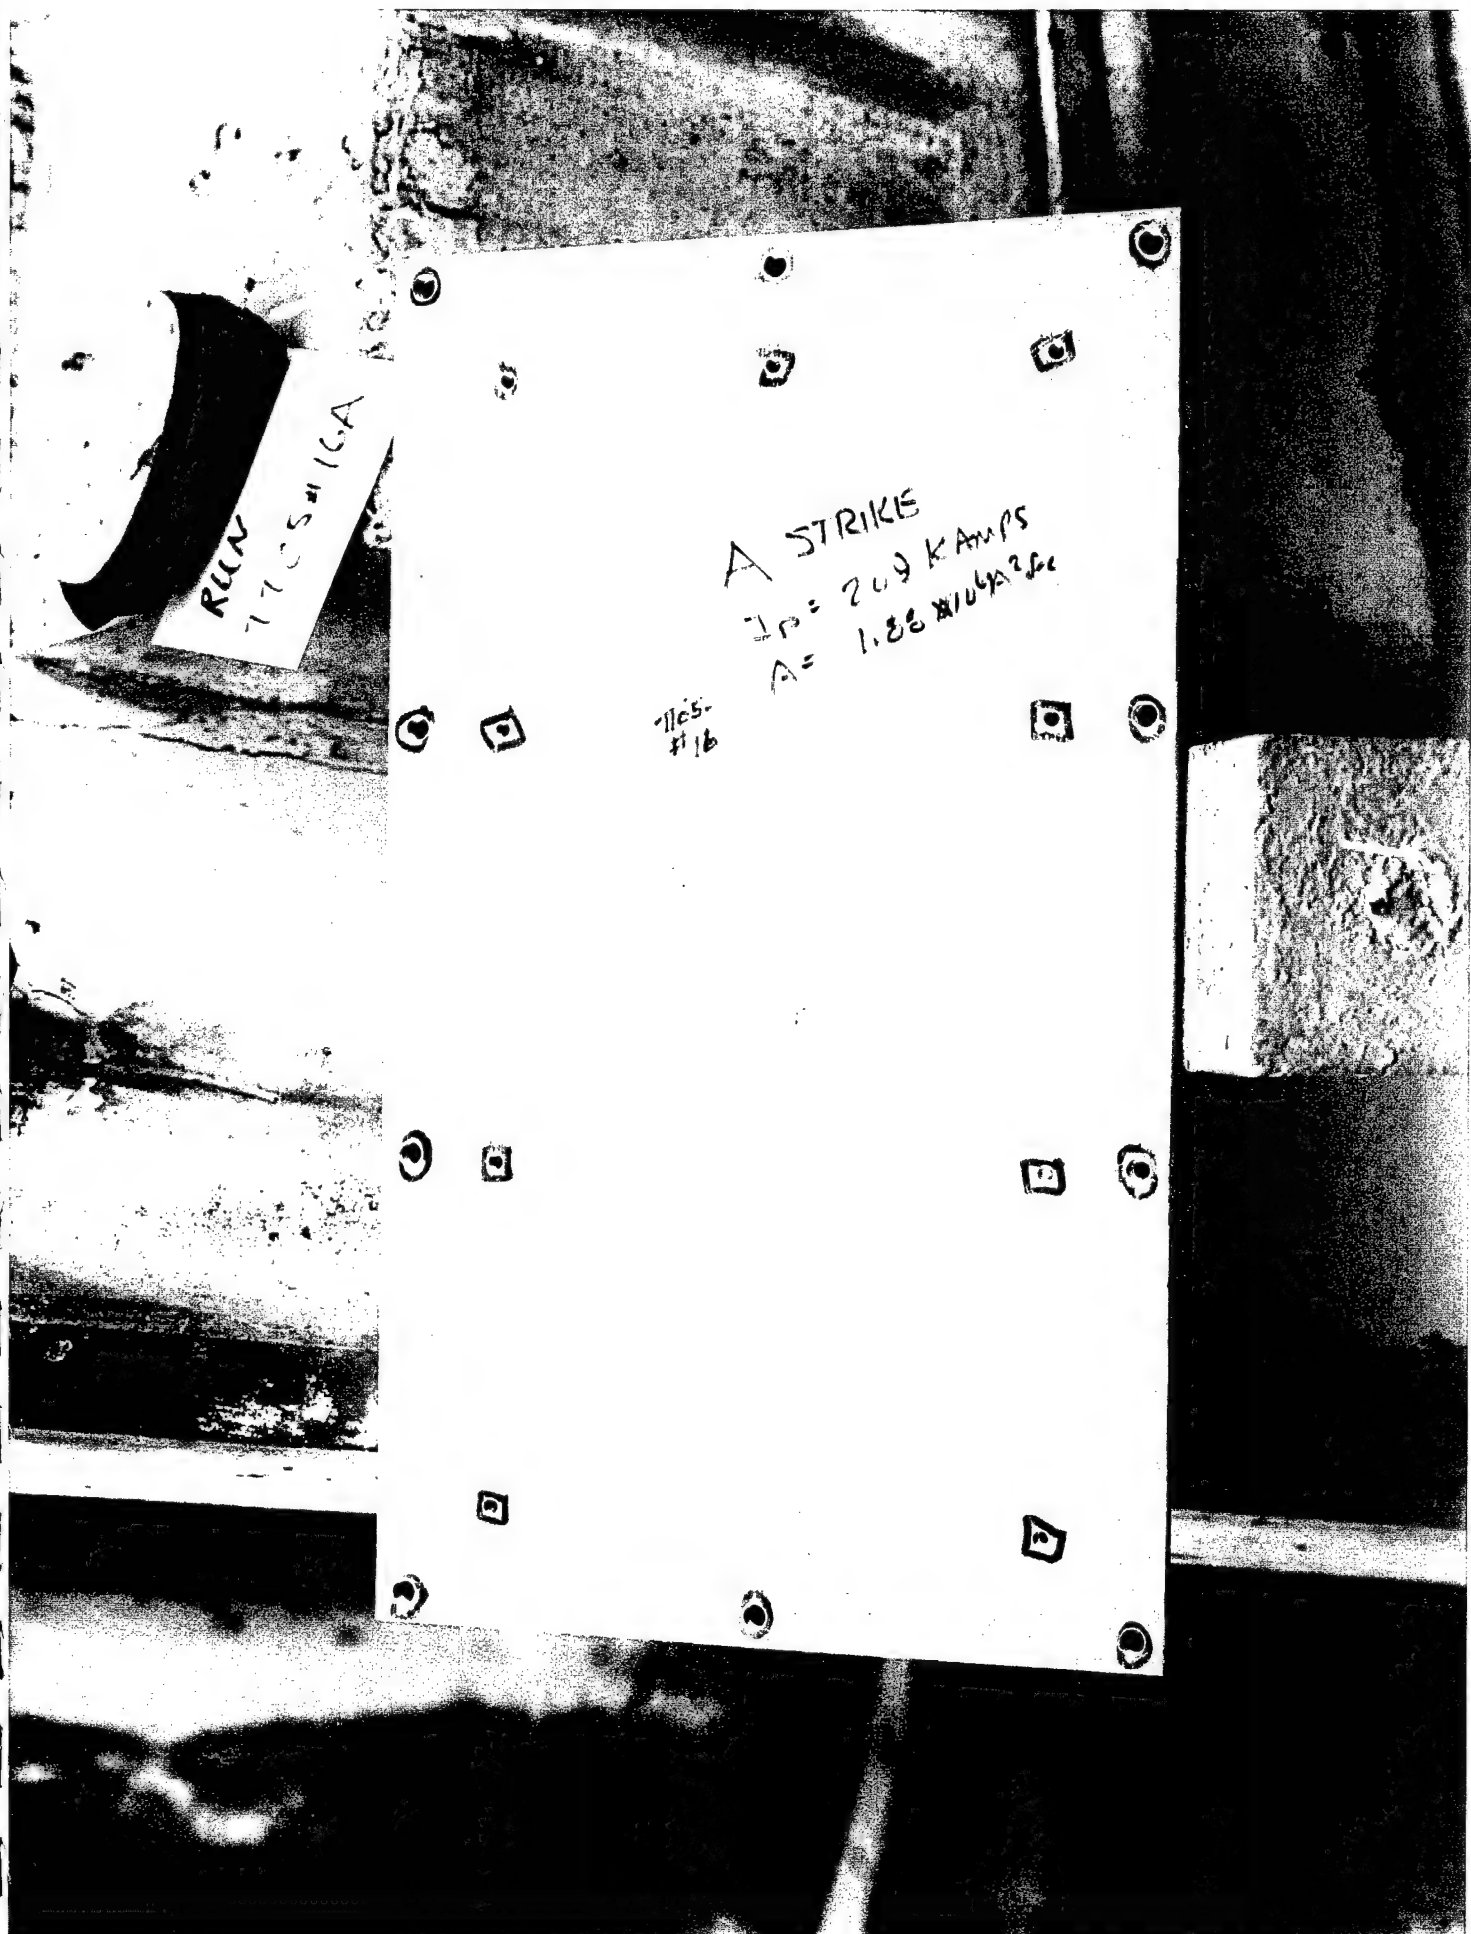
Figure B-75. Resultant Damage Due to Component A to Panel TTC5#16, Back View (No Gap).

The application of the high current (Component A) direct strike lightning environment to frustum calibration panel TTC5#16 with the discharge probe touching the panel did not appear to result in any significant difference of loss of MCC-1 TPS coating than to the test panels which utilized a 1-inch gap between the discharge probe and the test panels. Figures B-73 through B-75 of Appendix B illustrate the damage on the panel due to the application of the Component A direct strike lightning waveform.
